### U.S. GEOLOGICAL SURVEY

#### MEMORANDUM

**Subject:** Ferguson Rock Slide, Mariposa County, California

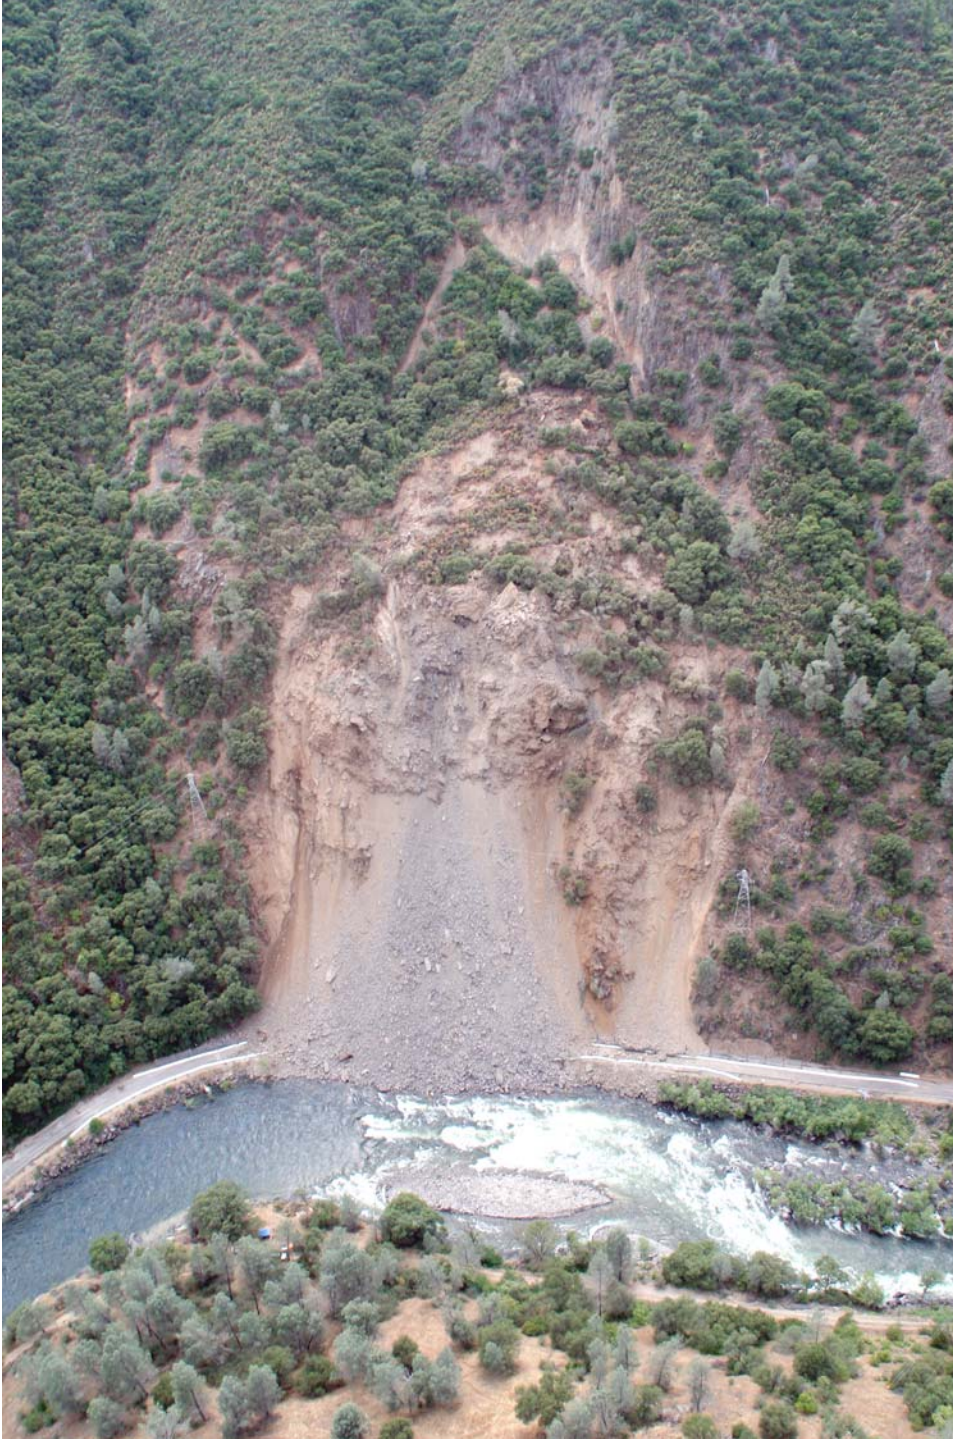
**Figure 1. Oblique aerial photograph of Ferguson Rock Slide. Merced River in foreground is flowing left to right. Photo taken by Ed Harp, USGS on June 13<sup>th</sup>, 2006.**

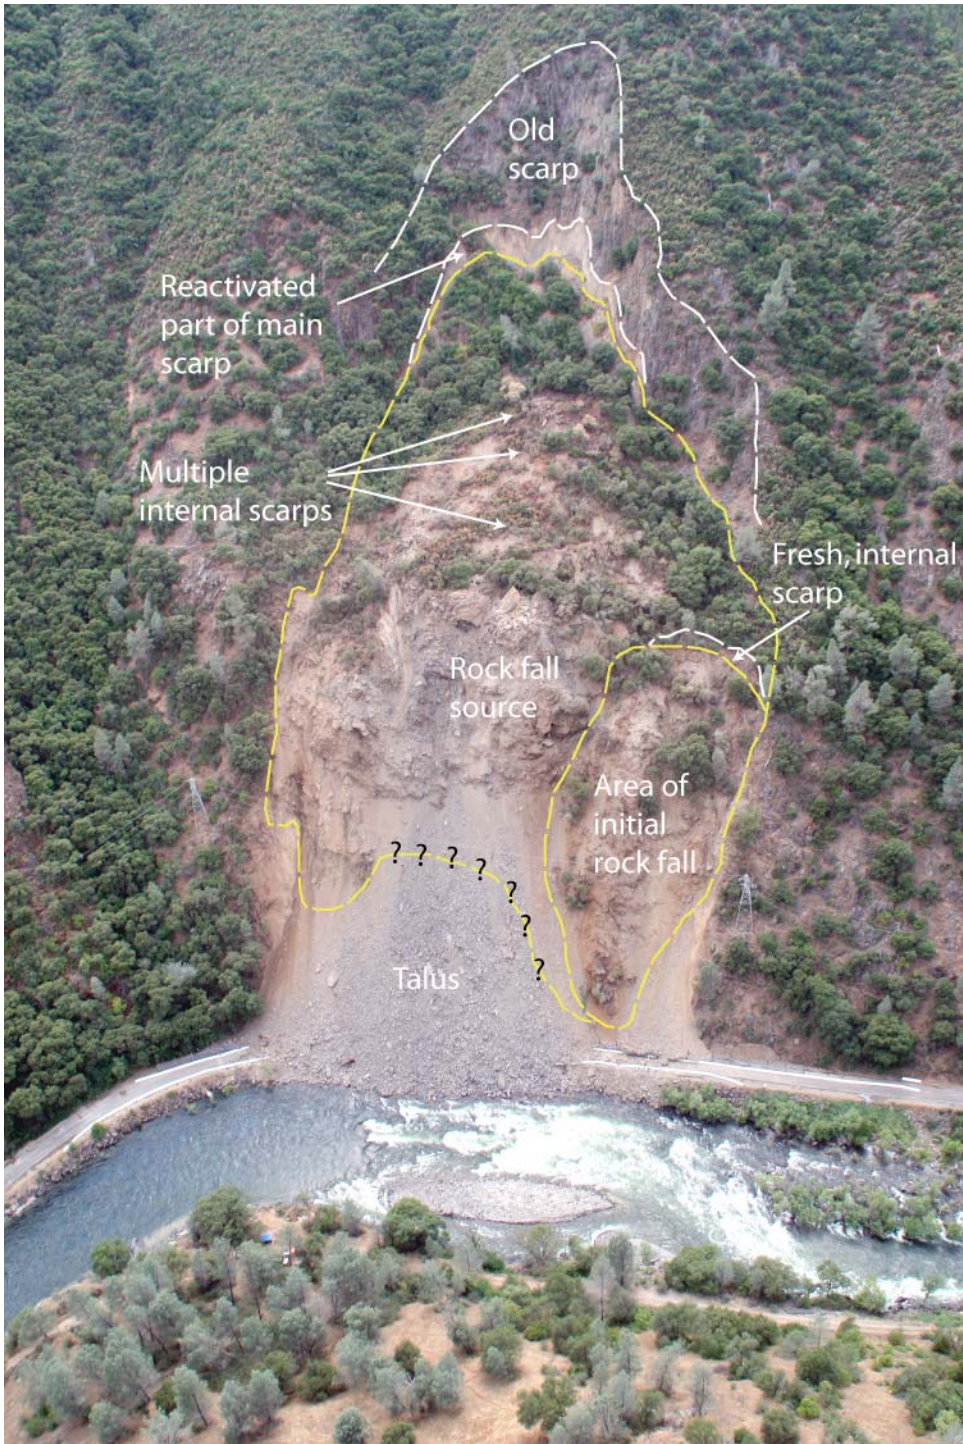
- The main slide mass appears to be a reactivation of an older rock slide. Recent motion on the older main headscarp (Figure 2) is about 30-40 feet. The basal shear surface of the rock slide does not toe out below the steep, disrupted rocks at the head of the talus slope but extends farther downslope to near the bottom of the slope (see Figure 2). The right side (looking downslope) of the slide toe has shed enough rock debris recently to exhume the shear surface in this area. Sheared slide material resting over intact bedrock is clearly visible on the lower right

**Figure 2. Oblique aerial photograph of Ferguson Rock Slide. Dashed yellow lines indicate extent of the rock slide based on visual inspection. Rock-fall source area, talus, and new scarps are indicated. Photo taken by Ed Harp on June 13<sup>th</sup>, 2006.**

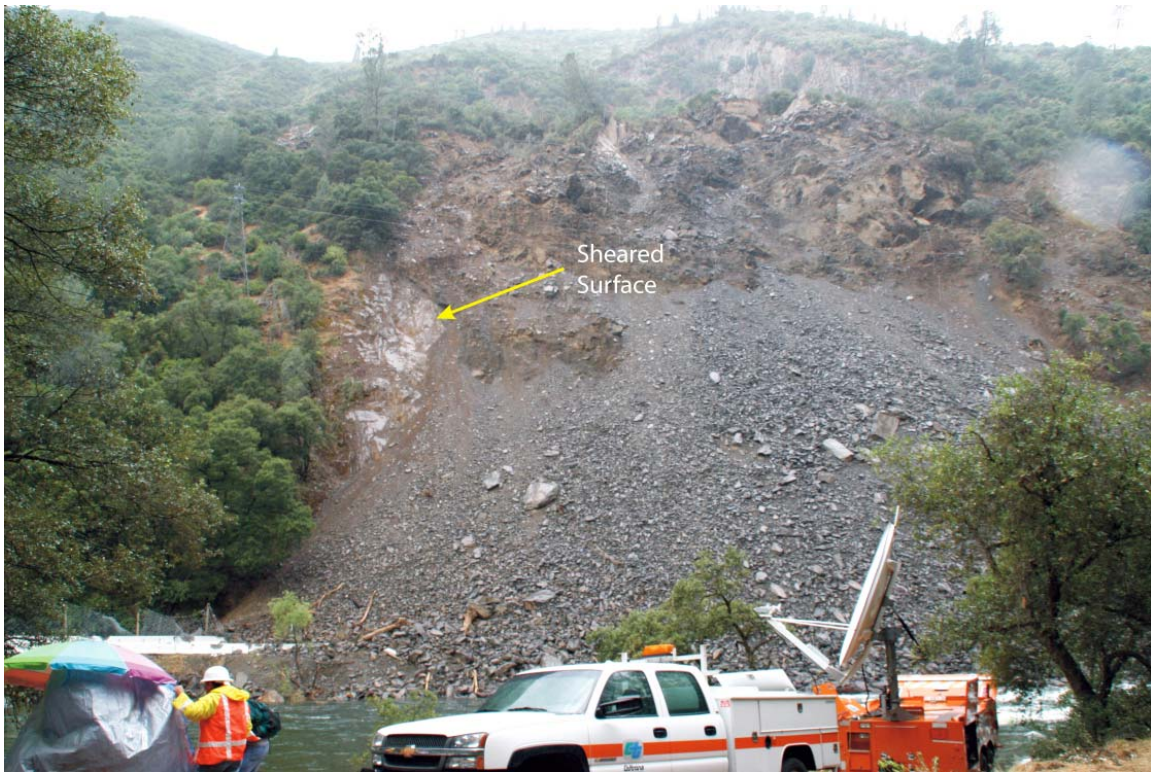
- margin of the slide (Figure 3). The left side of the slide toe is the area where rock fall was first noticed in April. This portion of the slide mass may be a separate rock slide as evidenced by the scarp above it shown in Figure 3. The exact location of the basal shear surface under the talus slope is unknown.

**Figure 3. Photograph of Ferguson Rock Slide taken from the opposite bank of the Merced River on June 13<sup>th</sup>, 2006. Recently exhumed shear surface on the lower right margin of the slide is indicated.**
